WOOD-DESTROYING ORGANISMS INSPECTION REPORT

Lake Mary, FL 32746. Date of Inspection: 4/15/2019.
Company City, State and Zip Code

Address of Property inspected: **SAMPLE REPORT**

Structure(s) on Property Inspected Single family home & detached garage only.

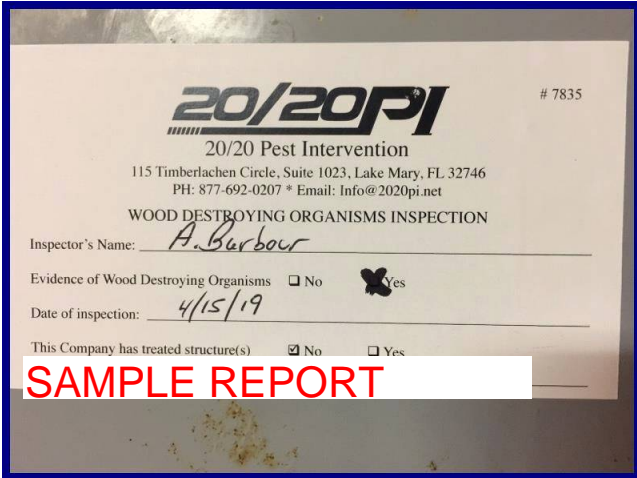
Today's inspection sticker.

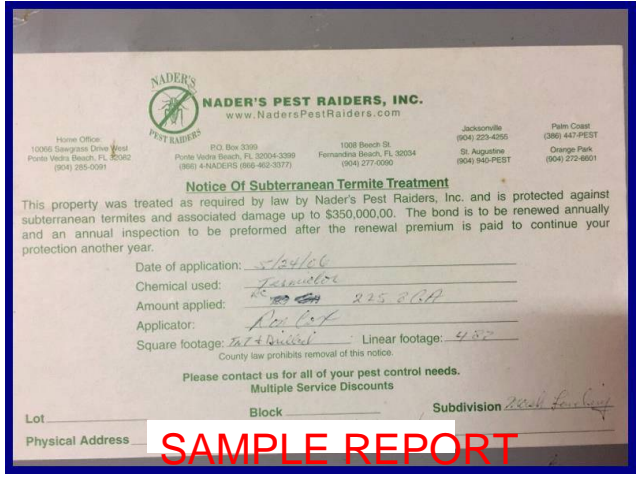
Naders pest control, treatment sticker.

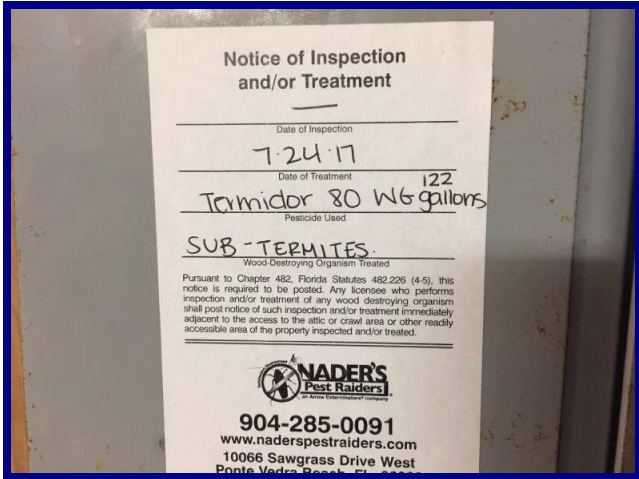
Naders pest control, treatment sticker.

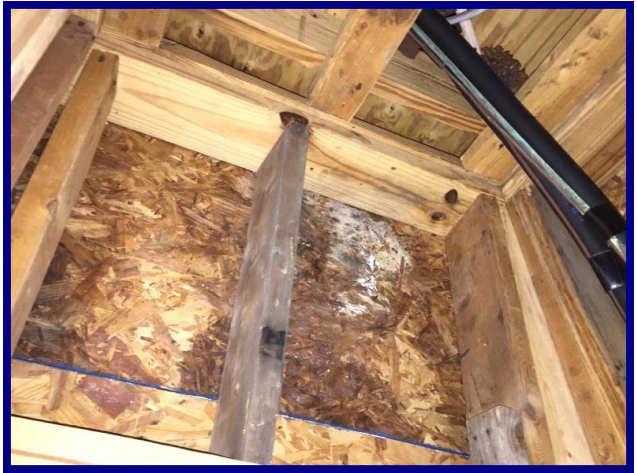
3. **DAMAGE** caused by WDO(s) was observed and noted as follows:
Wood decay fungi damage observed at Several areas lower garage doors- left garage. 2) Lower left and right door jams at exterior right closet. 3) Wall OSB sheathing inside upper above doors at left and right exterior closets. 4) Lower window sash guest suite over left garage east windows, left window sash. 5) Lower window sash right rear, right garage.
(Common Name, Description and Location of all visible damage - Describe damage - use additional page, if needed)

Wood decay at wall sheathing | left exterior closet.

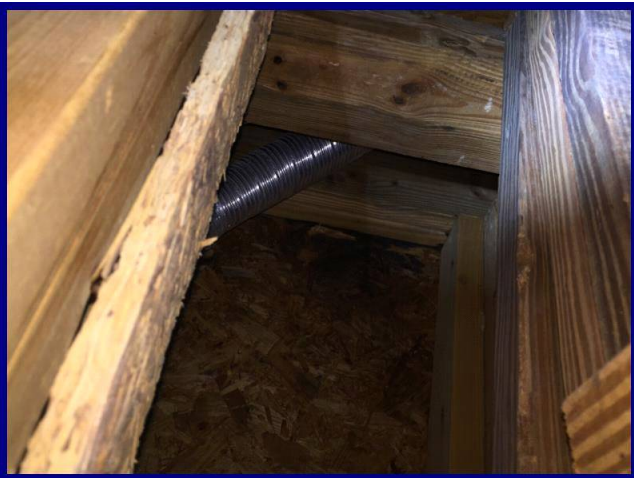
Wood decay at wall sheathing up high in closet right exterior.

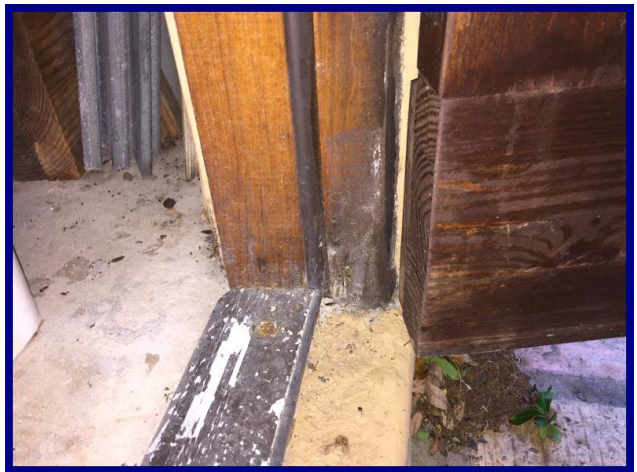
Wood decay at lower right door jam, exterior right closet.

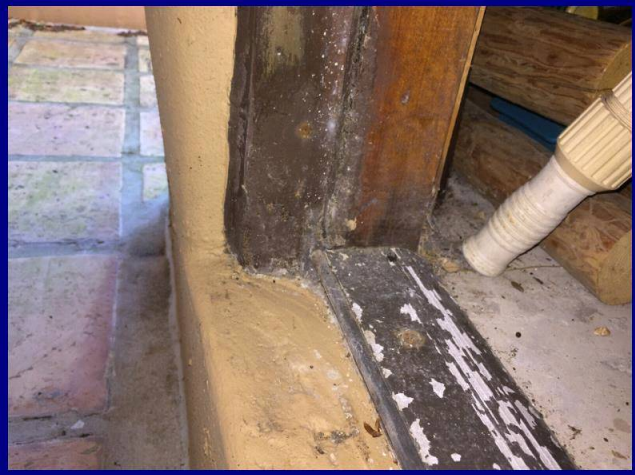
Wood decay lower left door jam, at right exterior closet.

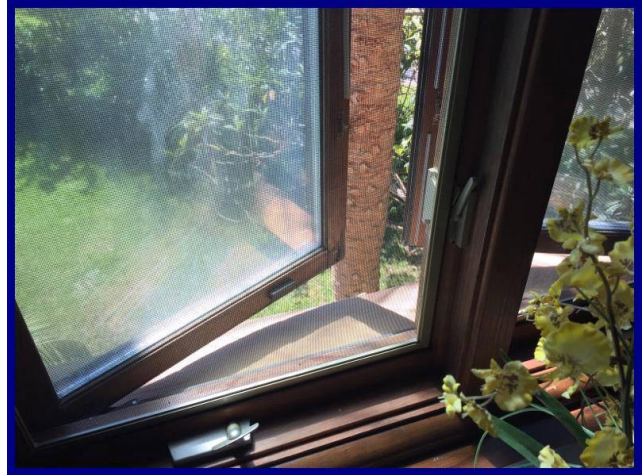
Section 2, B. 1. continued 4) Lower window sash guest suite over left garage east windows, left window sash. 5) Lower window sash right rear, right garage.

Wood decay At lower left sash, east facing window at guest suite over left garage.
